**Flood Control Project Maintenance
Levee Inspections**

Maintenance Issue Types Only, Levee Inspection Report By Mile - Spring 2018

Sutter Maintenance Yard Maintenance Area 0013

Waterway	Bank	Unit Miles	Inspection Start/End	Inspector
Unit No. 01 Cherokee Canal	Right	18.19	04/17/2018 04/17/2018	Bob Duffey

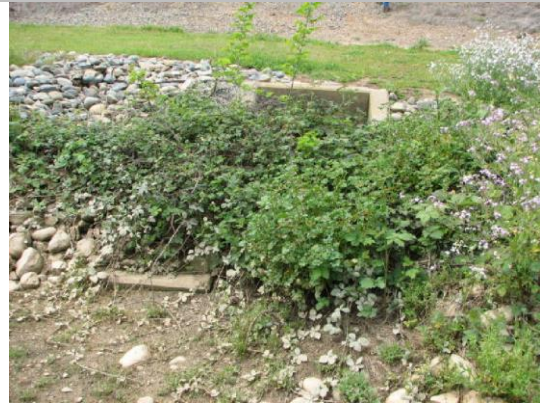
Photo 3 of 3 : UCIP_SP_2018_52182_66698.jpg

FS_ID:52182
DS_ID:16831
EP_NO: N/A
Repair Type: Urgent
Crossing Status: Found
UCIP Comments: 6/14/2017 Still no sign of WS pipe end. Pipe may need to be traced with GPR and excavated to determine if the WS end was properly capped after the Headwall and pipe sections were removed. Pipe has been selected to be internally cleaned and inspected as part of the DMP project. (DWR Sutter Yard - AFreitag)11/16/2016 WS structures still removed. (DWR Sutter Yard - AFreitag)10/17/2016 Landowner removed WS concrete headwall and pipe section through floodway to make room for orchard. The area disturbed appears to be from WS toe to where the mature trees are located within floodway, approximately 45 feet from WS toe. Crossing is classified as Urgent with potential levee integrity issues due to the disturbance of the WS without prior approval from the CVFPB. (DWR UCIP - omagana)
4/28/2016 Landowner appears to have removed the WS headwall and pipe to make room for planting more orchard trees. LS pipe end was full of water as it has no where to drain to anymore. Changing to urgent listing but it currently does not affect the levee integrity. (see photos 8, 9, & 10) (DWR Sutter Yard - afreitag)7/14/2015 Crossing appears in good condition. No noticeable issues to report. (DWR Sutter Yard - afreitag)5/21/2014 Same as last inspection. (DWR Sutter Yard - afreitag)12/2/2013 Pipe section was dug up and repaired. Crossing is now in good condition. (DWR Sutter Yard - afreitag) 4/17/2012 Pipe collapse on WS 10 feet from toe, needs repair. From WS, sediment is visible inside pipe. (DWR UCIP - omagana)

WS headwall, rock protection, and outlet blocked by shrub.

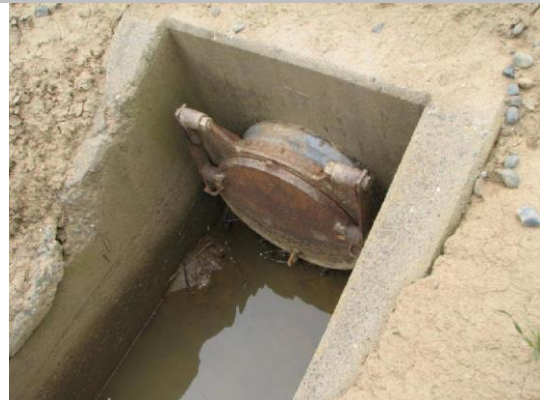
Photo 2 of 3 : UCIP_SP_2018_52188_66724.jpg

Flap gate on WS.

FS_ID:52188
DS_ID:16349
EP_NO: N/A
Repair Type: Non-Urgent
Crossing Status: Found
UCIP Comments: 6/14/2017 Both pipe ends and gates are mostly buried- need to be dug out. Pipe has been selected to be internally cleaned and inspected as part of the DMP project. (DWR Sutter Yard- A/Freitag)11/16/2016 Both gates closed but partially buried and unable to open. (DWR Sutter Yard- A/Freitag)4/28/2016 Sediment build up on both gates blocking them from operating properly.7/14/2015 Crossing appears in good condition. No noticeable issues to report.5/21/2014 Same as last inspection.12/2/2013 Same as last inspection.7/15/2013 Stem on LS screw gate has been replaced and is now full functional.4/17/2012 LS slide gate stem is bent and prevents gate from fully closing. Both WS and LS have been cleared of debris and sediment. This crossing was listed in the USACE Periodic Inspection report as Corp's inspect ID#USACE_CESPK_M13D_2011_p_0162 for inoperable gates on WS & LS due to sediment and grass blocking inlet and outlet.

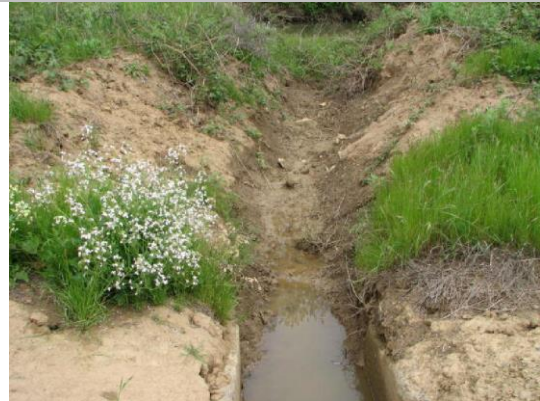
Photo 3 of 3 : UCIP_SP_2018_52188_66726.jpg

Recent sediment removal on WS.

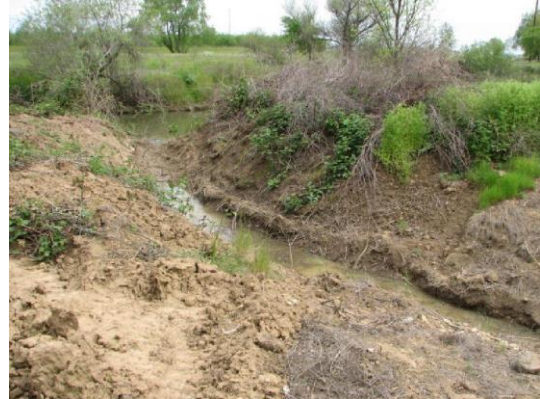
Photo 3 of 3 : UCIP_SP_2018_52189_66732.jpg

Sedimentation cleared on WS.

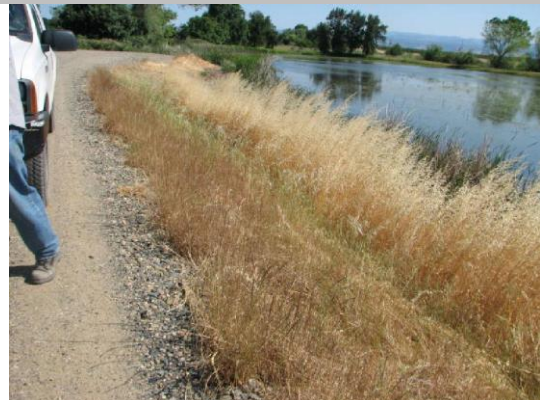
Photo 2 of 3 : UCIP_SP_2018_52190_66738.jpg

WS slope covered by dense vegetation.

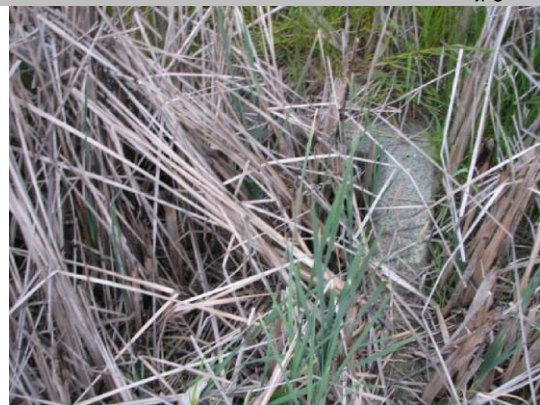
Photo 2 of 3 : UCIP_SP_2018_52191_66741.jpg

WS flap gate blocked by debris.

Comment Code					
Inspector Comment					
<p>FS_ID:52191 DS_ID:16365 EP_NO: N/A Repair Type: Non-Urgent Crossing Status: Found UCIP Comments: 6/14/2017 Appears abandoned- needs to be done properly. WS gate was buried/submerged and the LS slide gate is still damaged and buried. Pipe has been selected to be internally cleaned and inspected as part of the DMP project. (DWR Sutter Yard- A/Freitag)11/16/2016 Both LS and WS gates buried. (DWR Sutter Yard- A/Freitag)4/28/2016 Abandoned crossing. Ls screw is still bent and mostly buried.7/14/2015 LS screw gate is still damaged and buried. Crossing is non-functional.5/21/2014 Same as last inspection.12/2/2013 Same as last inspection.7/15/2013 Slopes have been cleared of vegetation and are in good condition. LS screw gate is still bent and silted over.4/18/2012 LS slide gate covered with silt. Slide gate is bent. Crossing appears not be in use. Limited inspection on WS and LS slope due to dense vegetation. Need photos of cleared slopes. FIELD_STRUCT_DESC: *ABANDONED* 24-inch corrugated metal drainage pipe through the levee, 7.9 feet below the crown. Flap gate on the waterside (WS) end. Screw gate on the landside (LS) end. Concrete "U" headwalls on both ends. [Additional Reference(s): DWR Levee Log, 1993. USACE Sacramento O&M Manual 519, June 1962 (HLM 3.82)] FS Date: 6/16/2017 12:35:50 PM</p>

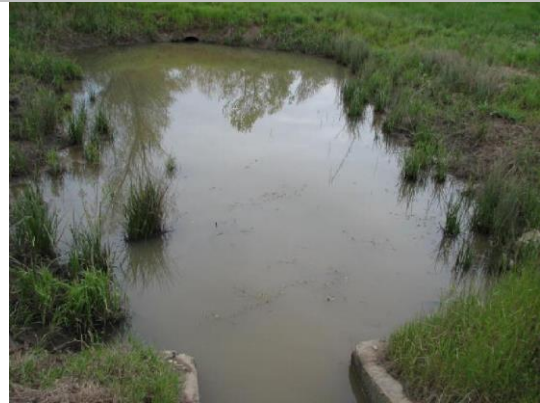
Photo 3 of 3 : UCIP_SP_2018_52195_66763.jpg

WS view of outlet cleared of vegetation.

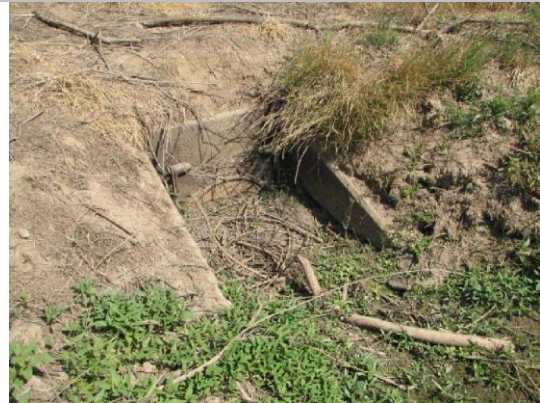
Photo 3 of 3 : UCIP_SP_2018_52201_66791.jpg

View of WS flap gate buried.

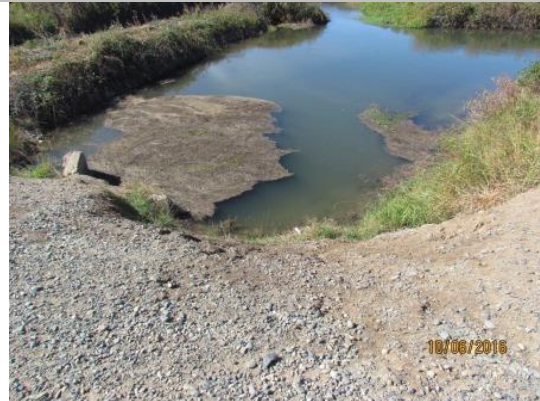
Photo 1 of 1 : SP_2018_MA0013_300_49_20180305_00007.jpg

View of the erosion site along the landside toe.

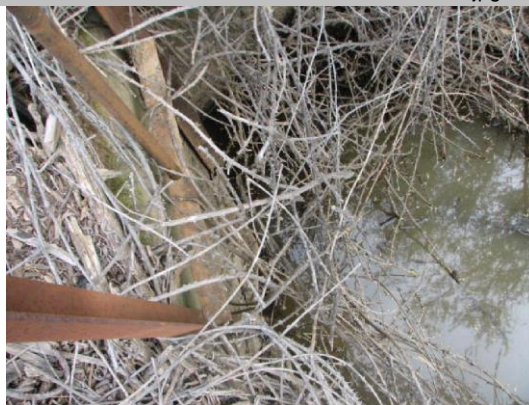
Photo 3 of 3 : UCIP_SP_2018_52223_66900.jpg

View of slide gate on WS. Debris blocking gate.

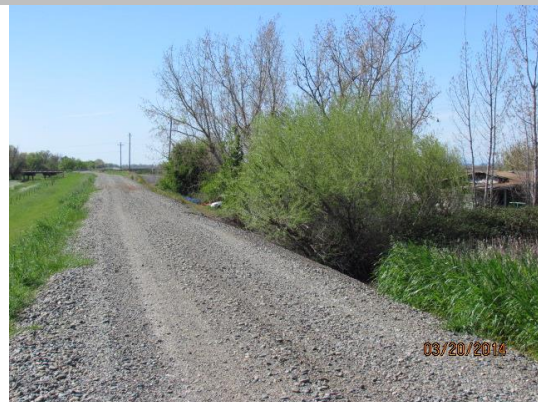
Photo 1 of 1 : SP_2018_MA0013_300_5_20180305_00002.jpg

View of the overgrown trees along the landside slope and toe.

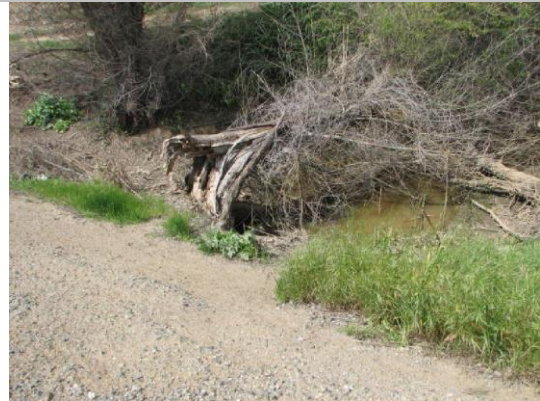
Photo 3 of 3 : UCIP_SP_2018_52239_66969.jpg

Tree fallen at LS headwall.

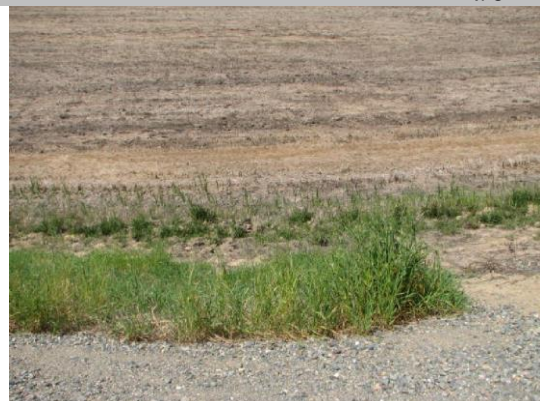
Photo 2 of 2 : UCIP_SP_2018_52240_66973.jpg

View of LS slope and toe. Unable to find welded plate on LS.

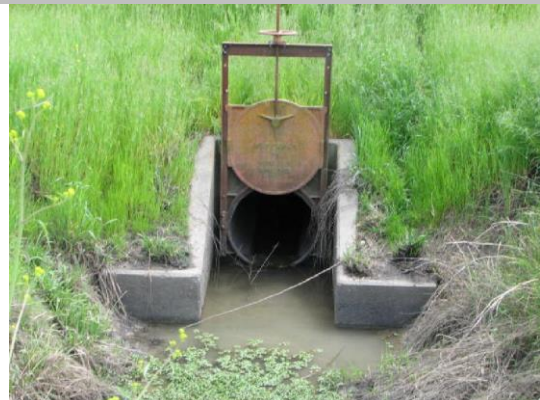
Photo 2 of 3 : UCIP_SP_2018_52242_66980.jpg

Slide gate located on LS toe. Dense vegetation present on LS slope.

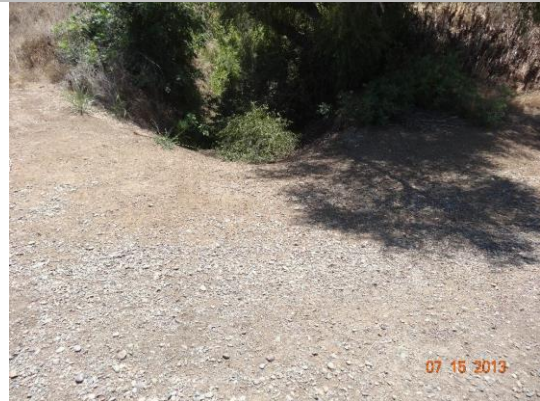
Photo 3 of 3 : UCIP_SP_2018_52242_66982.jpg

WS slope cleared of vegetation

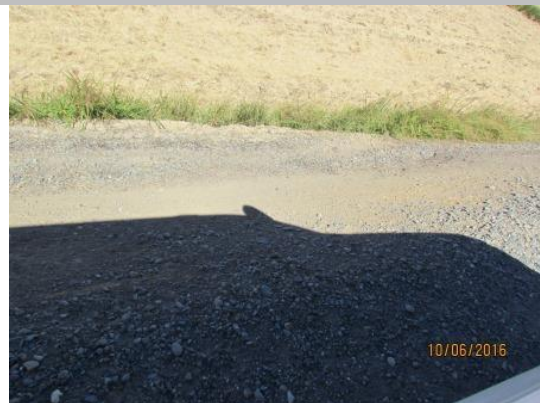
Photo 1 of 1 : SP_2018_MA0013_300_57_20180305_00010.jpg

View of slope instability along the landside slope.

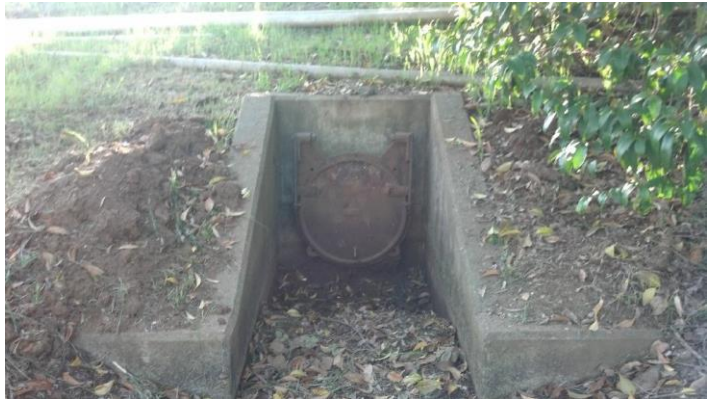
Photo 2 of 3 : UCIP_SP_2018_52111_45642.jpg

Headwall and flap gate on WS. Soil and pipes stockpiled next to headwall.

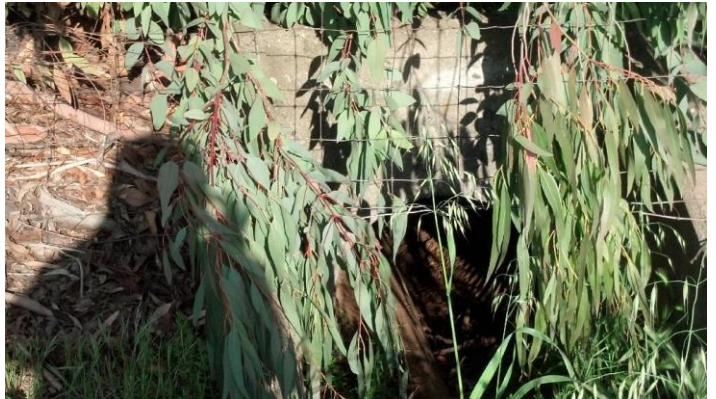
Photo 3 of 3 : UCIP_SP_2018_52111_45643.jpg

LS headwall blocked by overgrown branches.

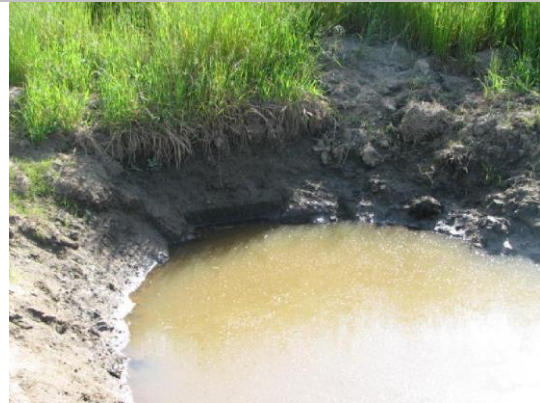
Photo 3 of 3 : UCIP_SP_2018_52121_67096.jpg

View of flap gate submerged on WS toe.

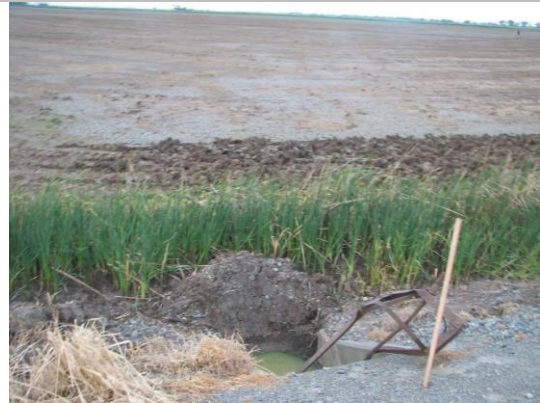
Photo 3 of 3 : UCIP_SP_2018_52129_67141.jpg

Overview of LS floor is higher in elevation than pipe invert causing build up sediment.

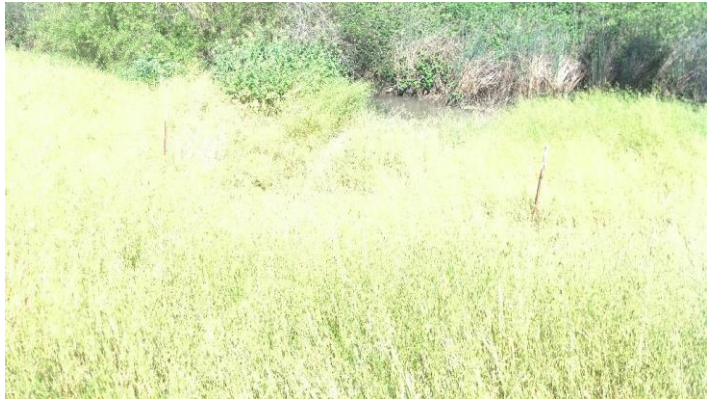
Photo 2 of 3 : UCIP_SP_2018_52157_67351.jpg

View of WS slope. Limited inspection due to the dense vegetation.

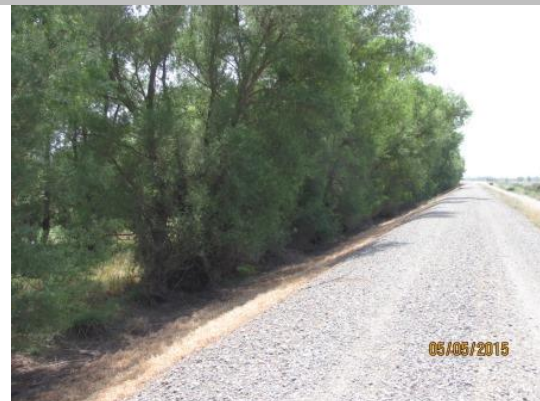
Photo 1 of 1 : SP_2018_MA0013_301_6_20180305_00002.jpg

View of the overgrown trees along the landside slope.

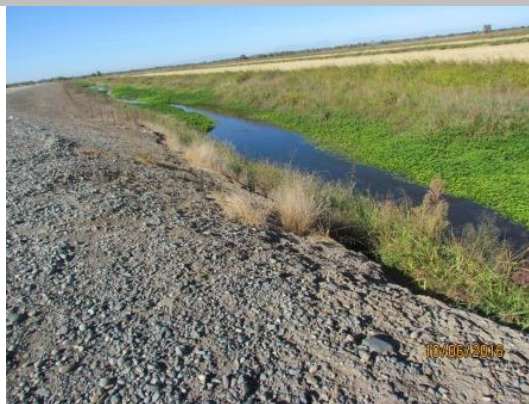
Photo 1 of 1 : SP_2018_MA0013_301_75_20180305_00022.jpg

View of the erosion along the waterside toe.

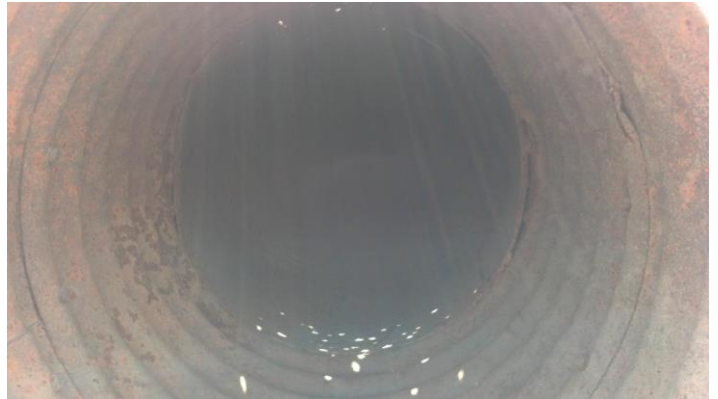
Photo 3 of 3 : UCIP_SP_2018_52168_67450.jpg

WS-view of internal pipe with severe corrosion-holes present along pipe wall.

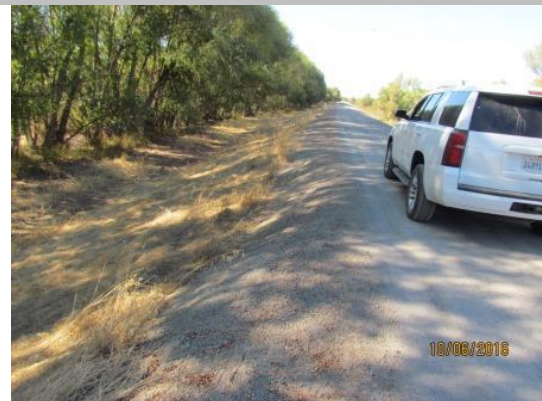
Photo 1 of 1 : SP_2018_MA0013_301_62_20180305_00016.jpg

View of slope instability issue along the landside slope.
